Navajo Abandoned Uranium Mine

Site Screen Report

Ryan No. 3 AUM Site

January 2011

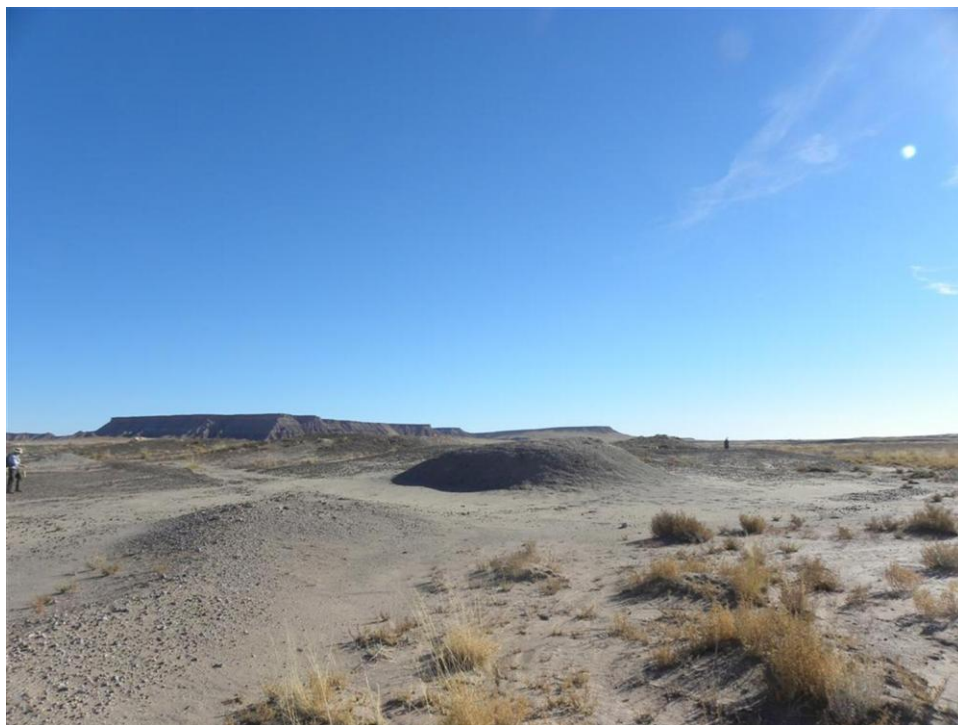
Photo 1. Ryan No. 3 mine site

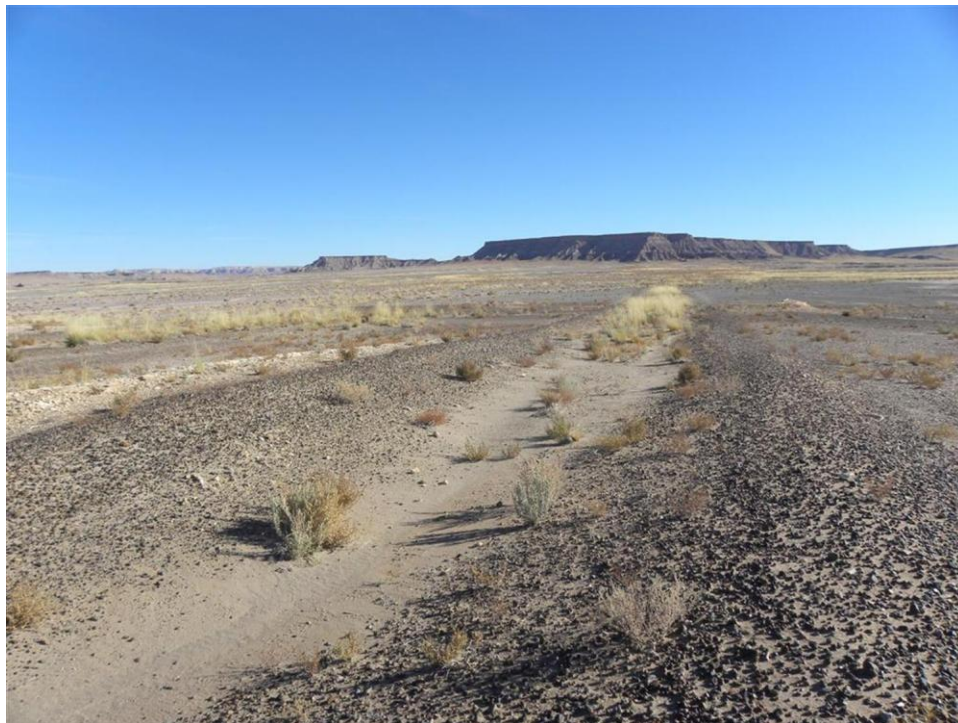
Photo 2. Ryan No. 3 mine site, diversion channel

Diversion channels on eastern and central portion of site, series of small reclamation caps intermixed with mounds surrounding petrified wood piles

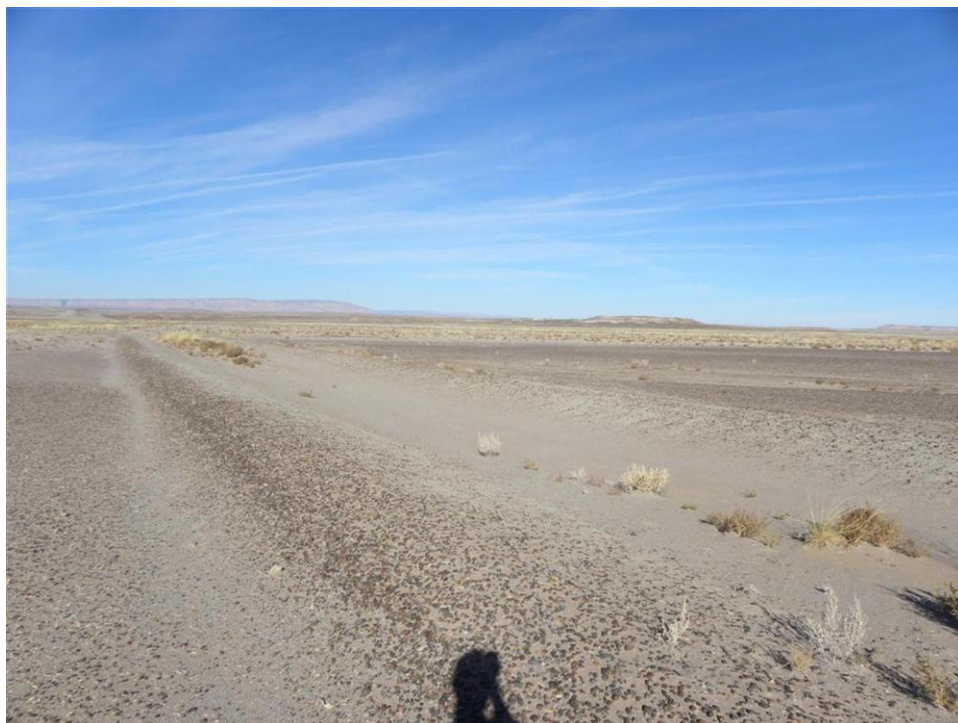
Photo 3. Ryan No. 3 mine site, diversion channel

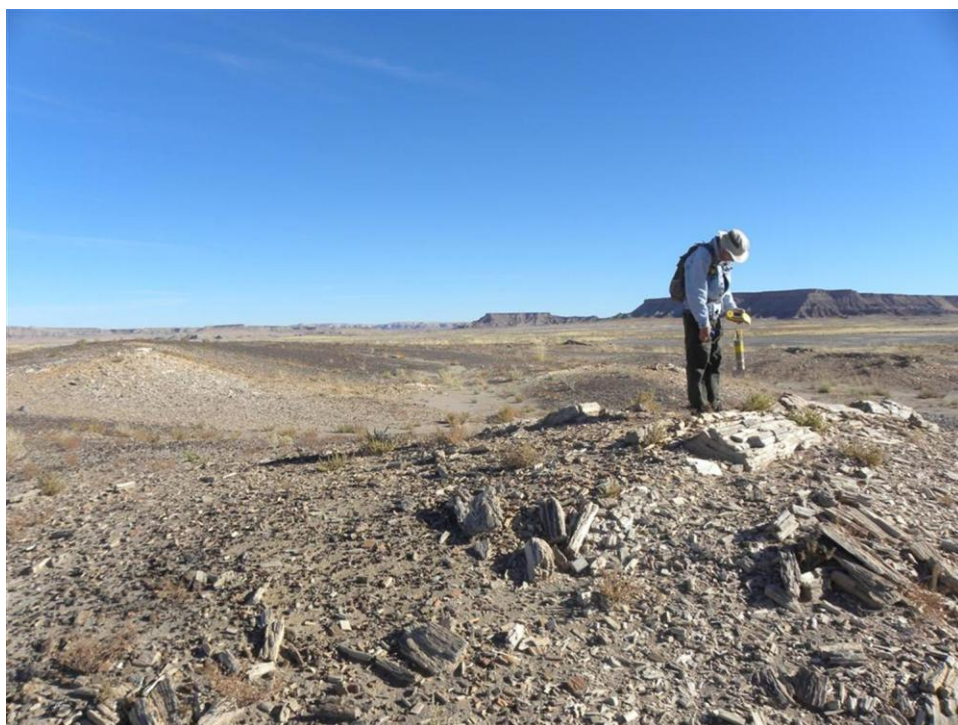
Photo 4. Ryan No. 3 mine site, reclamation caps and petrified wood piles

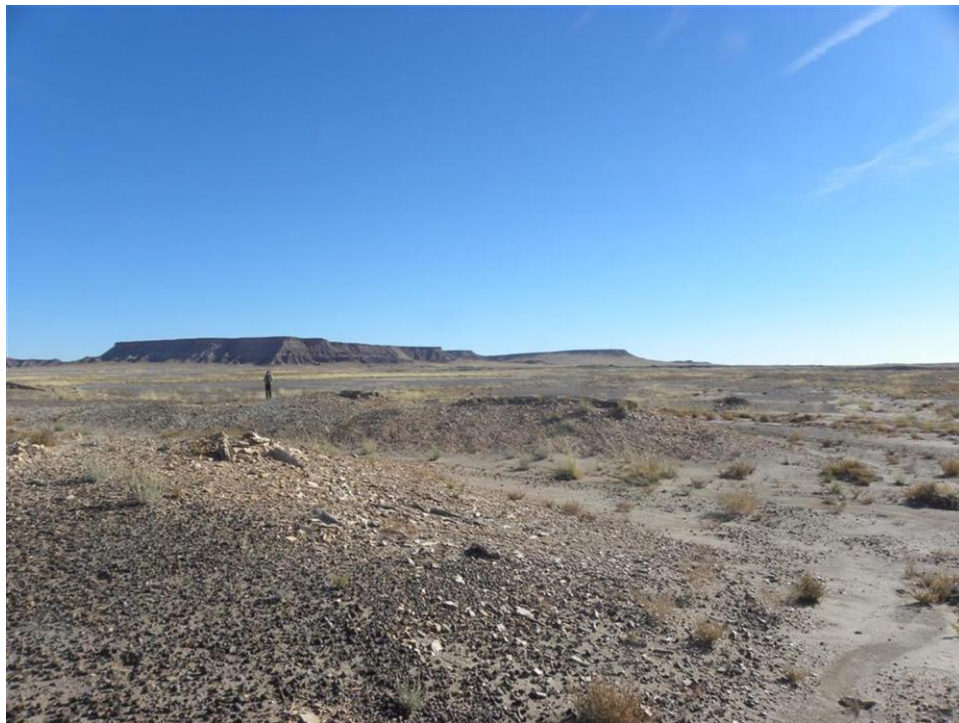
Photo 5. Ryan No. 3 mine site, reclamation caps and petrified wood piles

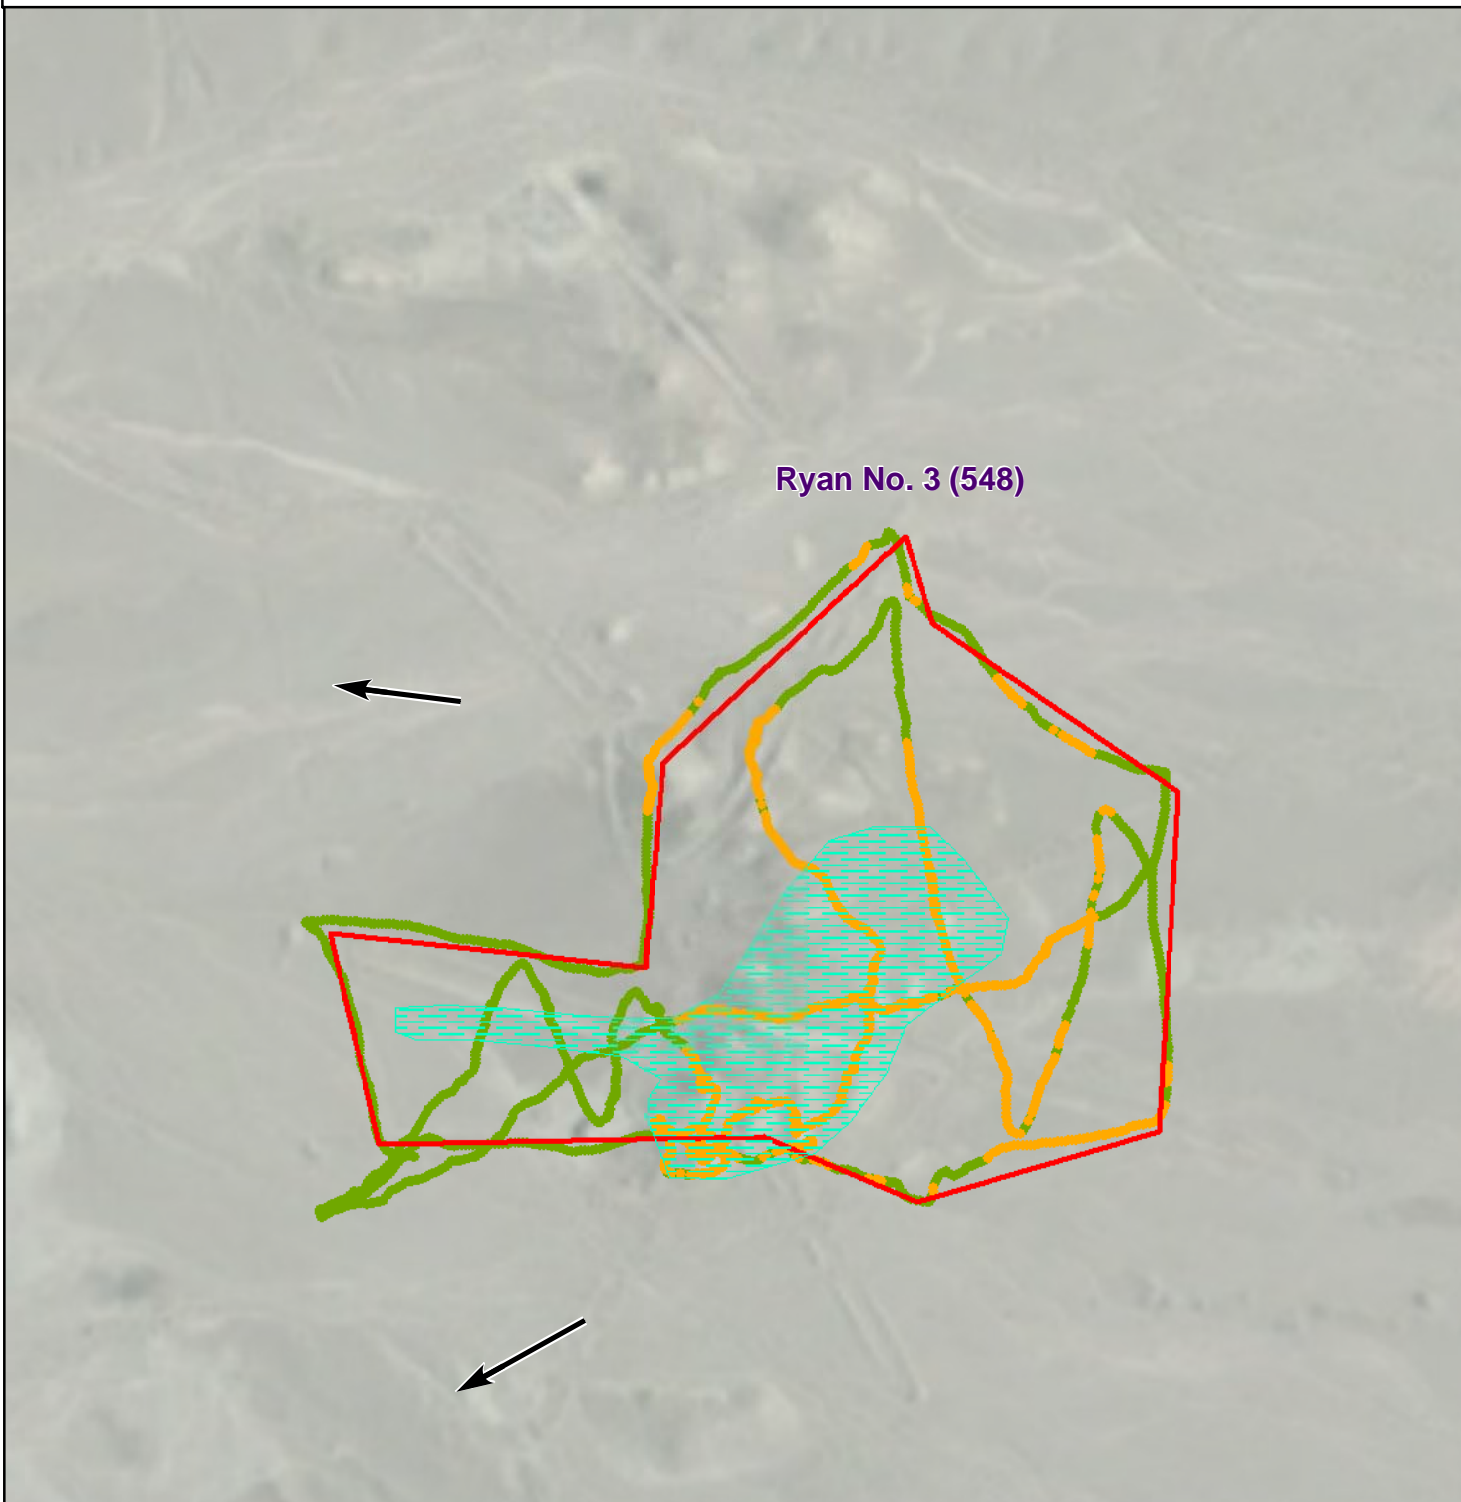
**Figure 1 - Gamma Radiation Measurements, Above Two Times
Ryan No. 3 (548)
Coalmine Mesa Chapter, Navajo Nation**

A total of 2,787 gamma radiation measurements were collected from the mine site, ranging from 10,217 cpm to 202,439 cpm. The measurements collected at the petrified wood piles were found at a maximum level of approximately 200,000 cpm. The measurements are represented in Figures 1 and 2.

Gamma survey conducted 11/2010
Measured as counts per minute (cpm)

Average background 11,885 cpm
